High-Speed Can Production Facility

Industry Issue/Challenge

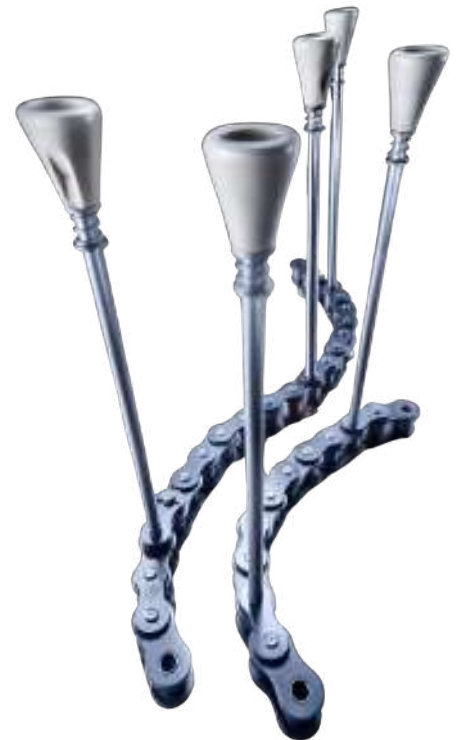
The chains are used in a pin oven system—part of the can making process—where aluminum cans are moved through ovens at extremely high speeds for curing. This high-load, high-temperature application requires precision, durability, and consistency under constant stress.

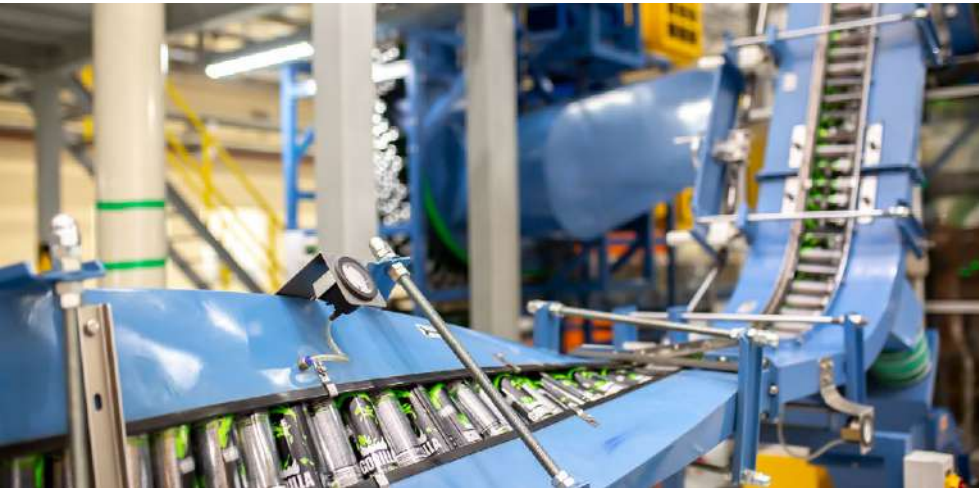
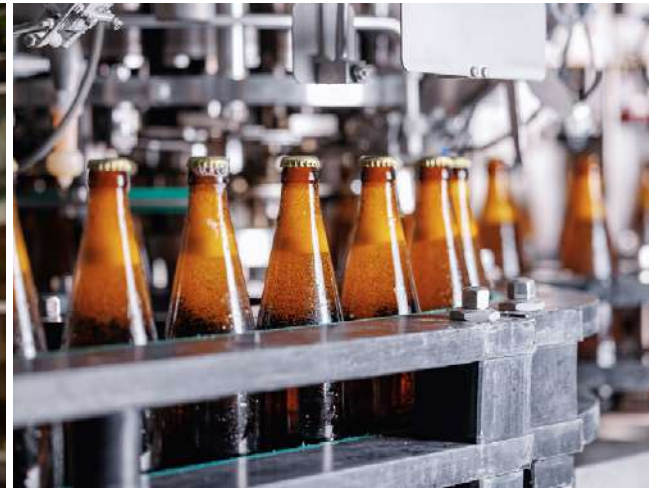
iwis supplied 60 riv pin oven chain, built to match the original chain's specifications but with enhanced durability and wear resistance. The facility also implemented the iwis CCM (Chain Condition Monitoring) system, which allowed the team to proactively track wear and schedule maintenance windows, eliminating costly surprises.
